**Town Park Retaining Wall Evaluation**  
Hopedale, Massachusetts

# **ENGINEERING ALTERNATIVES ANALYSIS REPORT**

Town of Hopedale  
November 22, 2023

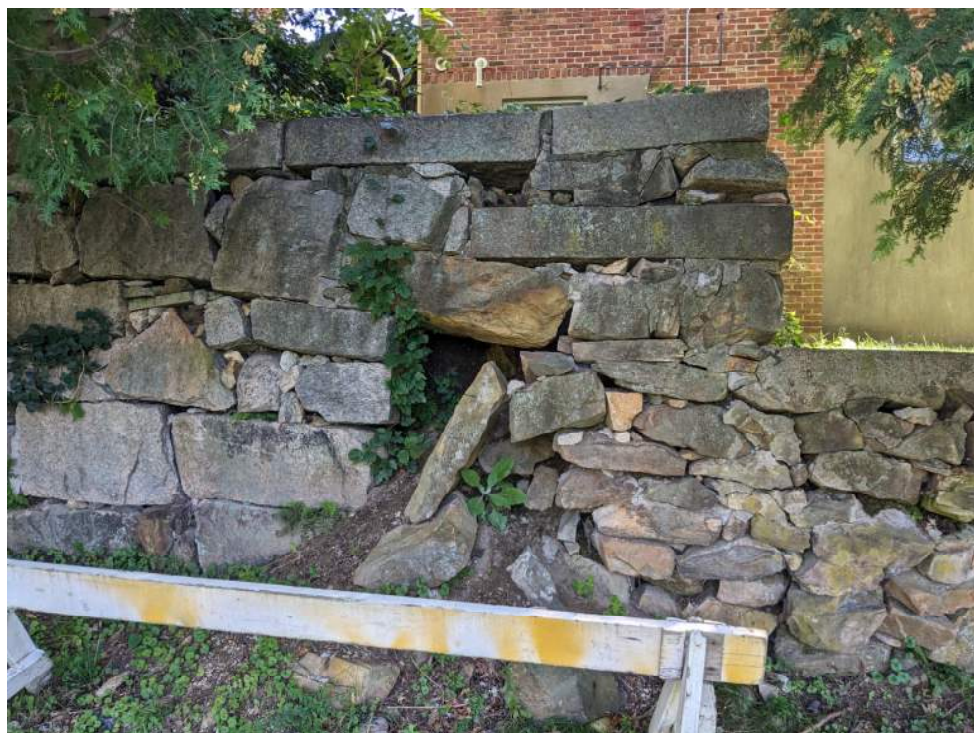
- Entire Length - Voids that ranged between 20 to 36-inches deep with vegetation growing through the exposed voids.
- Entire Length - Vegetation observed growing directly behind the top of the wall stem. Multiple large trees growing directly in front of this wall section.
- 2+55 to 2+80 - Failure of the wall where 12 to 24-inch stones have fallen out of the wall leaving a void approximately 3' W x 3' H x 2' D. Wall pushed outward by approximately 12-inches (Photo No. 4).

*Photo 4: View of wall failure, facing northeast at sta. 2+75*

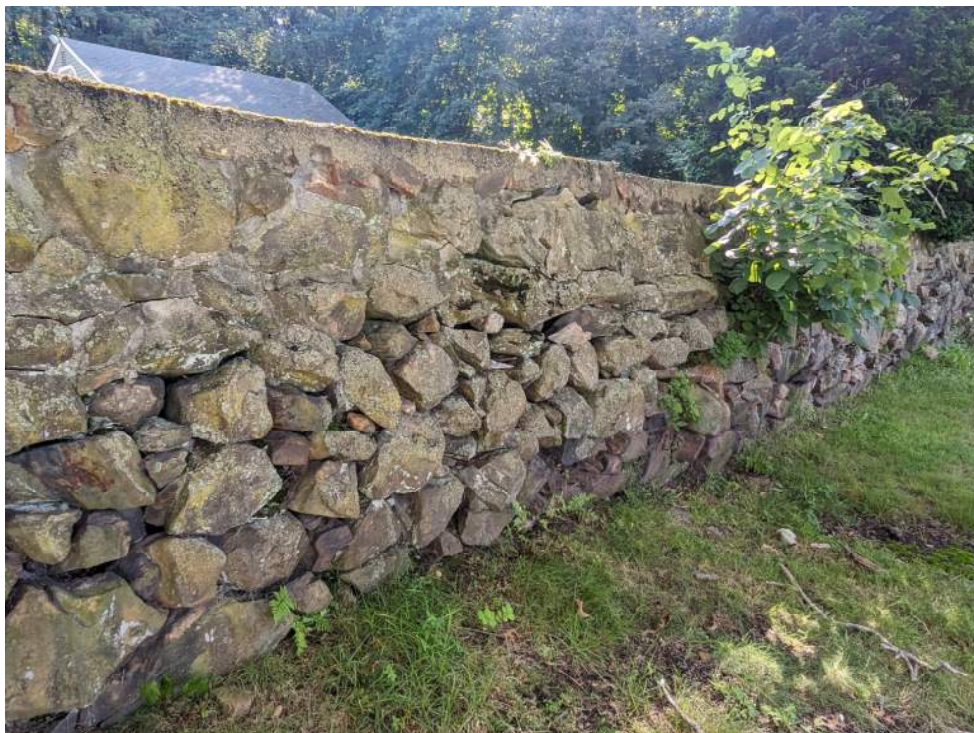
- Entire Length - Pointing between stones almost completely missing with only a few random locations remaining.
- Entire Length - Voids in this wall ranged from 6 to 24-inches deep with small vegetation growing within the voids on the wall face.
- Entire Length - Large vegetation and small trees growing directly behind and through some of the voids present along the wall (Photo Nos. 6 and 7). Large trees were also growing directly in front of this wall section.
- STA 2+95 - A single 4-inch diameter clay drainpipe protruded through the wall. The pipe appeared to be clogged and its origins are unknown.
- STA 3+50 to 4+00 - The wall was bulging outward in numerous locations by up to  $\pm 8''$  and had an irregular alignment. (Photo No. 6).

*Photo 6: View of northeast wall, facing southeast at sta. 3+55.*

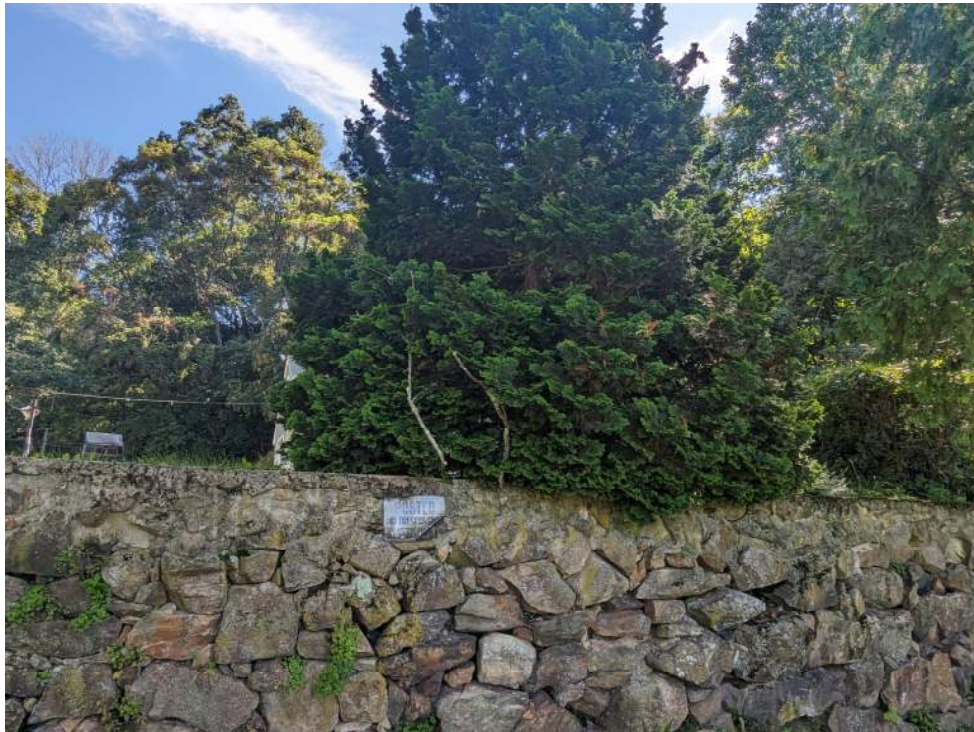
*Photo 7: View of northeast wall tree growing behind wall stem, facing east at sta. 3+80.*

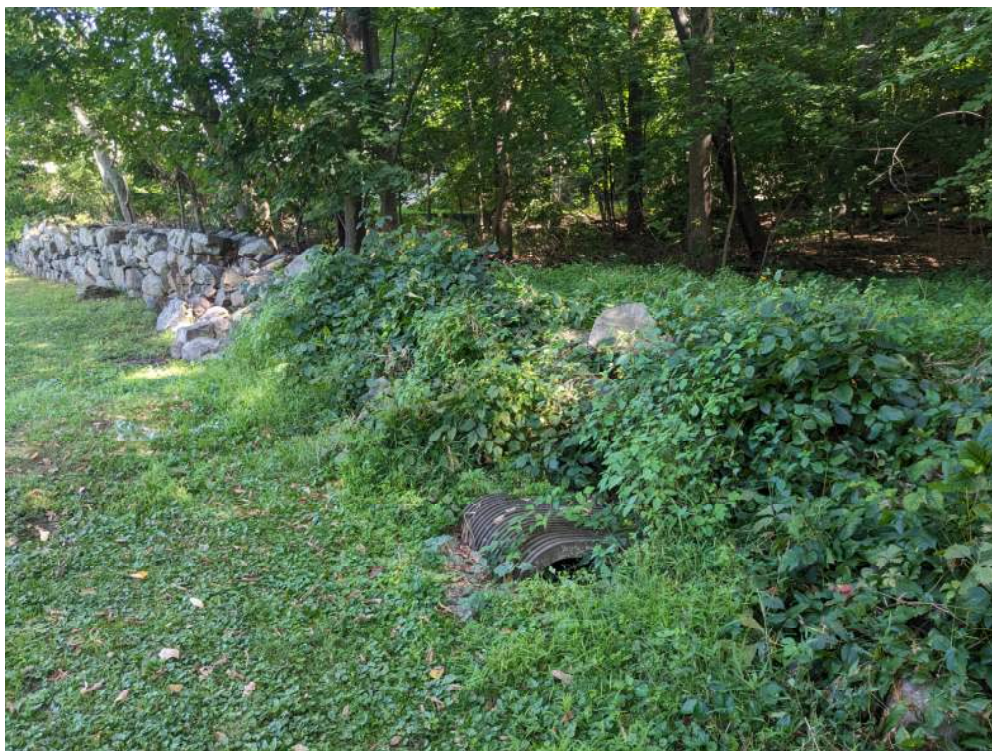
*Photo 9: View of drystacked stone wall overgrown with vegetation, facing northeast at sta. 5+19*

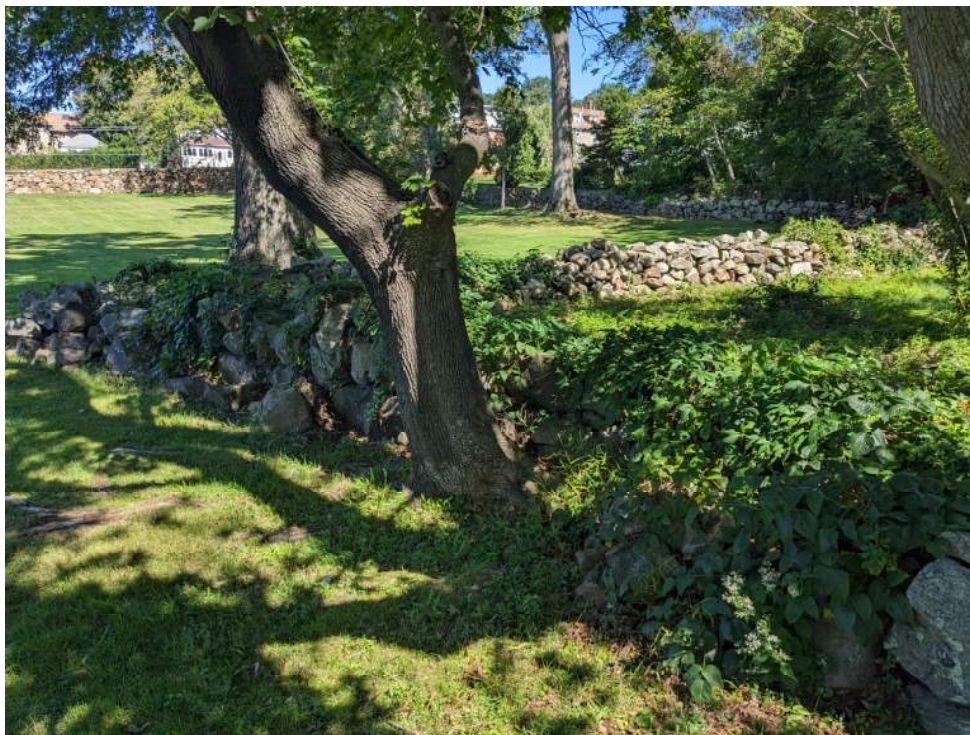
*Photo 10: View of drystacked stone wall toppled over and overgrown with vegetation, facing northeast at sta. 6+50*

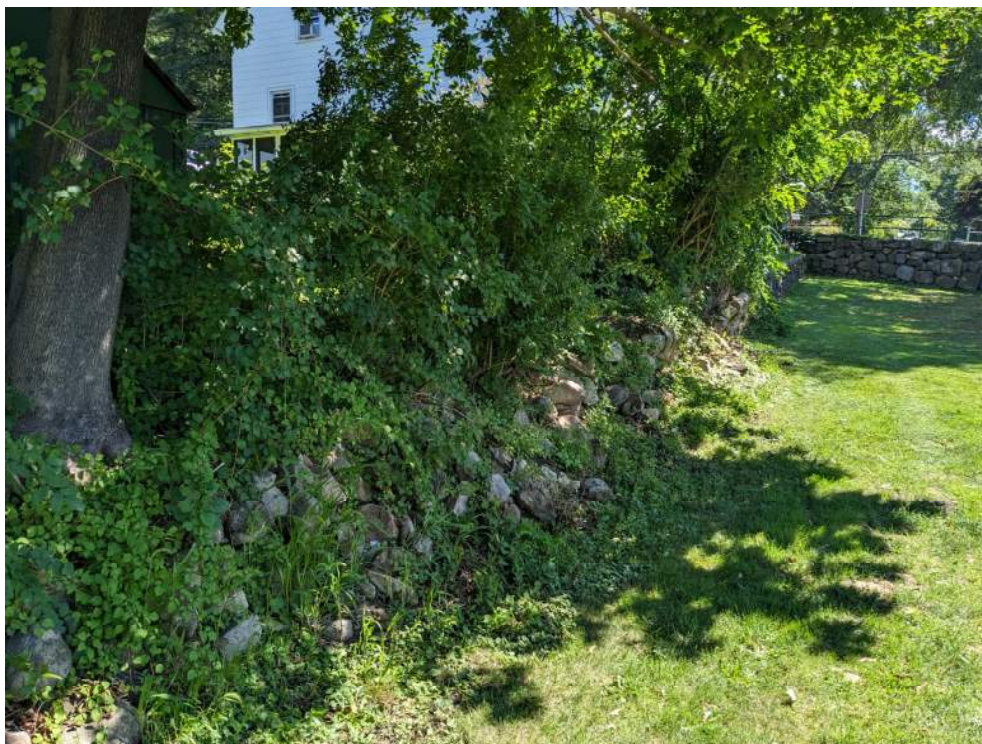
- Entire Length – Wall severely leaning outwards towards the Park and/or toppled over and failed (Photo Nos. 11 and 12).
- Entire Length – Loose stones 6 to 12-inches in size have fallen out of the wall structure and are no longer held together by mortar.
- Entire Length - Large trees and vegetation observed growing directly behind the wall stem.

*Photo 11: View of failed stone wall adjacent to 62 Freedom Street, facing southeast at sta. 9+60*

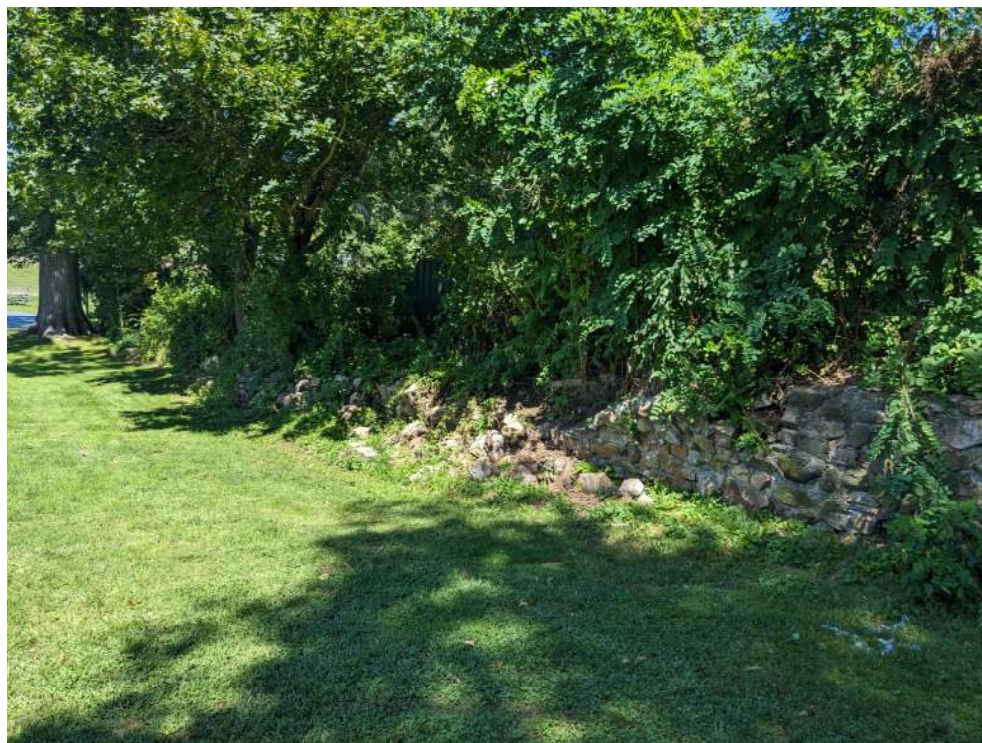
*Photo 12: View of failed wall overgrown with vegetation, facing north at sta. 10+15*

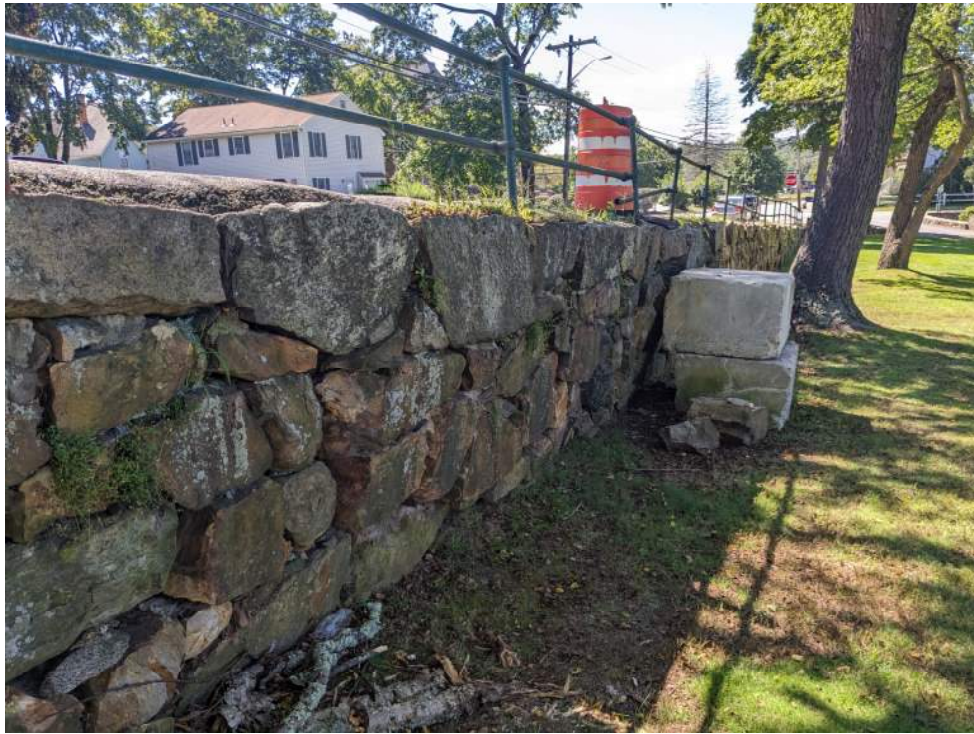
*Photo 15: View of bowing Freedom Street wall, facing southwest at sta. 11+60*

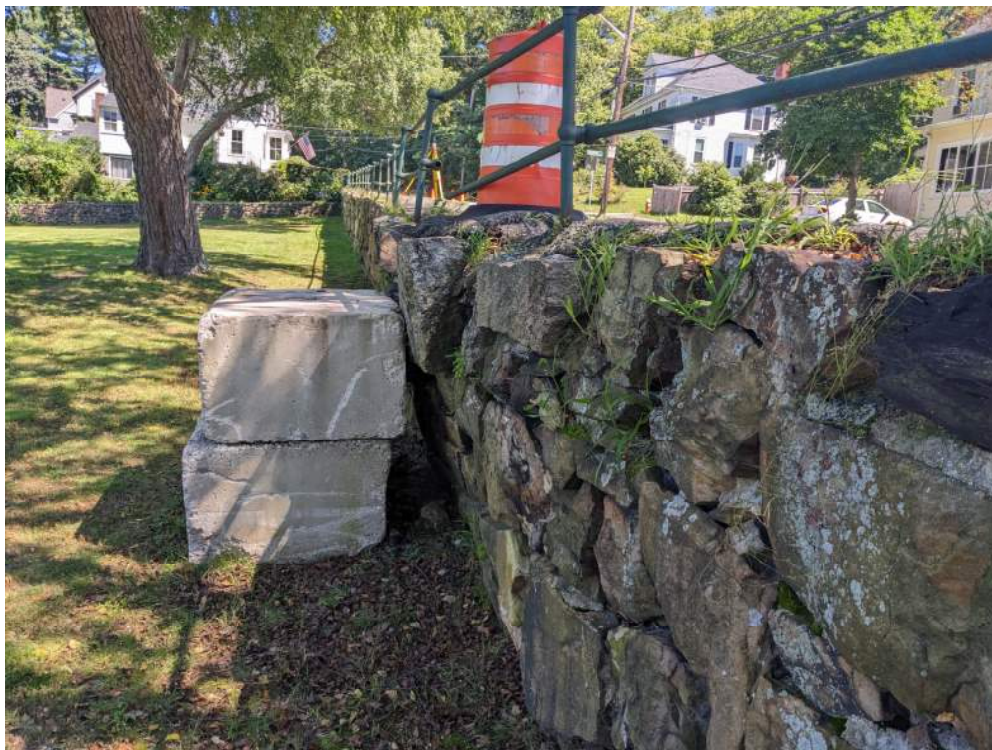
Condition of the wall ranged from poor to critical/failed condition with severe outward leaning and dislodged wall stones observed (Photo No. 16). Periodic pointing between the stones was also observed in this wall section. See below for a list of deficiencies noted:

*Photo 16: View of Freedom Street wall where failure occurred, facing east at sta. 12+10*

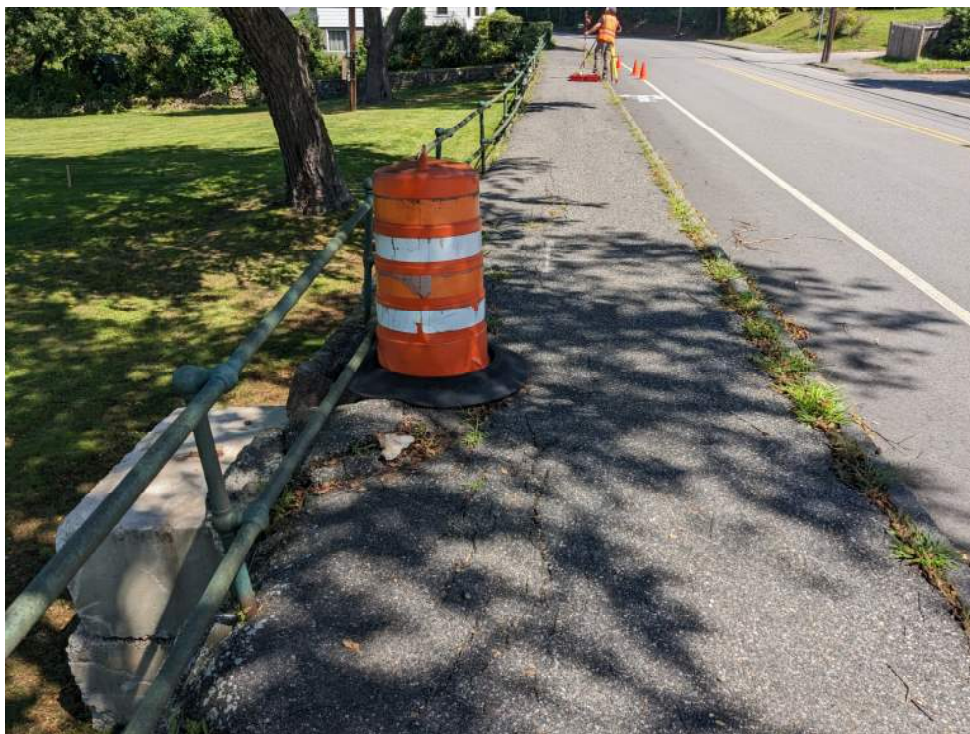
- Entire Length - Voids present ranging between 12 to 36-inches deep with an average depth of 18-inches.
- Entire Length - The guardrail on the top is in fair condition with minor to moderate corrosion throughout and spacing between the rails of approximately 18"
- Vegetation growing through the exposed voids.
- Entire Length - The wall appears to have been backfilled with large aggregate fill. Little to no fines were observed in the voids behind the wall.
- STA 11+70 to 12+00 - Failure of the wall where 12 to 36-inch stones have become completely dislodged from the wall structure. Wall pushed outward by approximately 24-inches. The wall is being temporarily supported by concrete blocks in front of it.
- STA 11+80 to 12+00 - Significant cracking and deterioration of the asphalt sidewalk and handrailing located above (Photo No. 17).

*Photo 17: View of deteriorated sidewalk above Freedom Street wall where failure occurred, facing east at sta. 12+10*

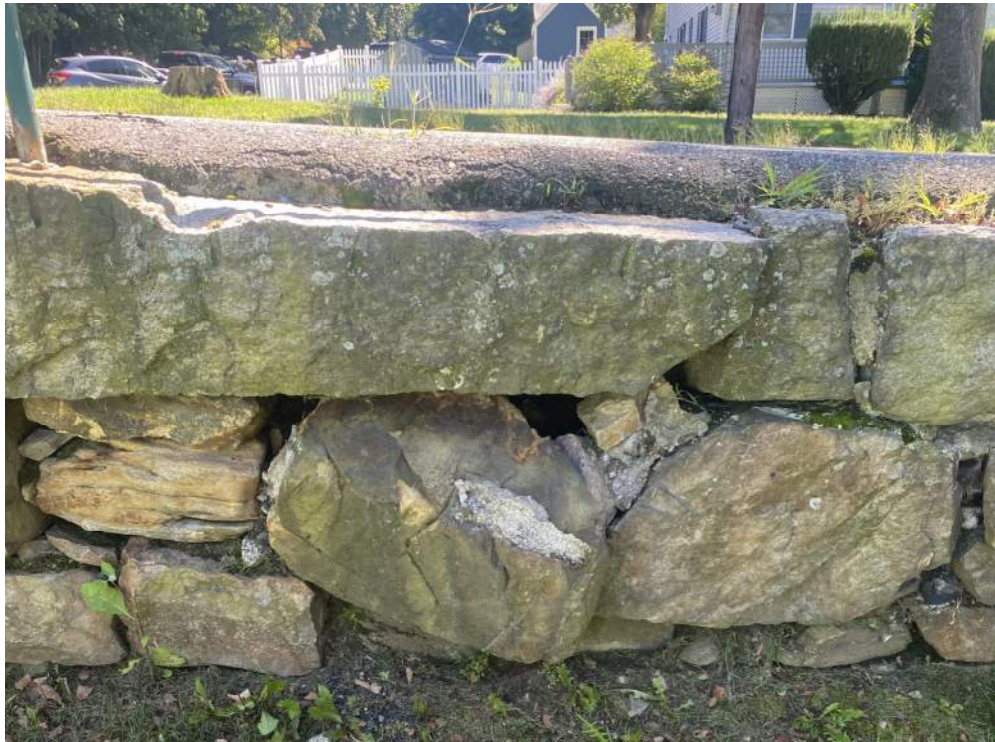
- Entire Length - Voids ranging between 12 to 36-inches deep with an typical depth of 18-inches.
- Entire Length - The guardrail on the top is in fair condition with minor to moderate corrosion throughout and spacing between the rails of approximately 18"
- Entire Length - Vegetation growing through the exposed voids.
- Entire Length - the wall was backfilled with large aggregate fill. Little to no fines were observed in the voids behind the wall.
- STA 12+30 to 12+50 - The wall was bulging outward by about 8" (Photo No. 18).
- STA 12+30 to 12+50 - Cracking and deterioration of the asphalt sidewalk and handrail on top of wall.
- STA 12+90 - Approximate 24-inch stone completely dislodged from the wall (Photo No. 19).

*Photo 19: View of loose stone in Freedom Street wall, facing southeast at sta. 12+90*
