**Town Park Retaining Wall Evaluation**  
Hopedale, Massachusetts

# **ENGINEERING ALTERNATIVES ANALYSIS REPORT**

Town of Hopedale  
November 22, 2023

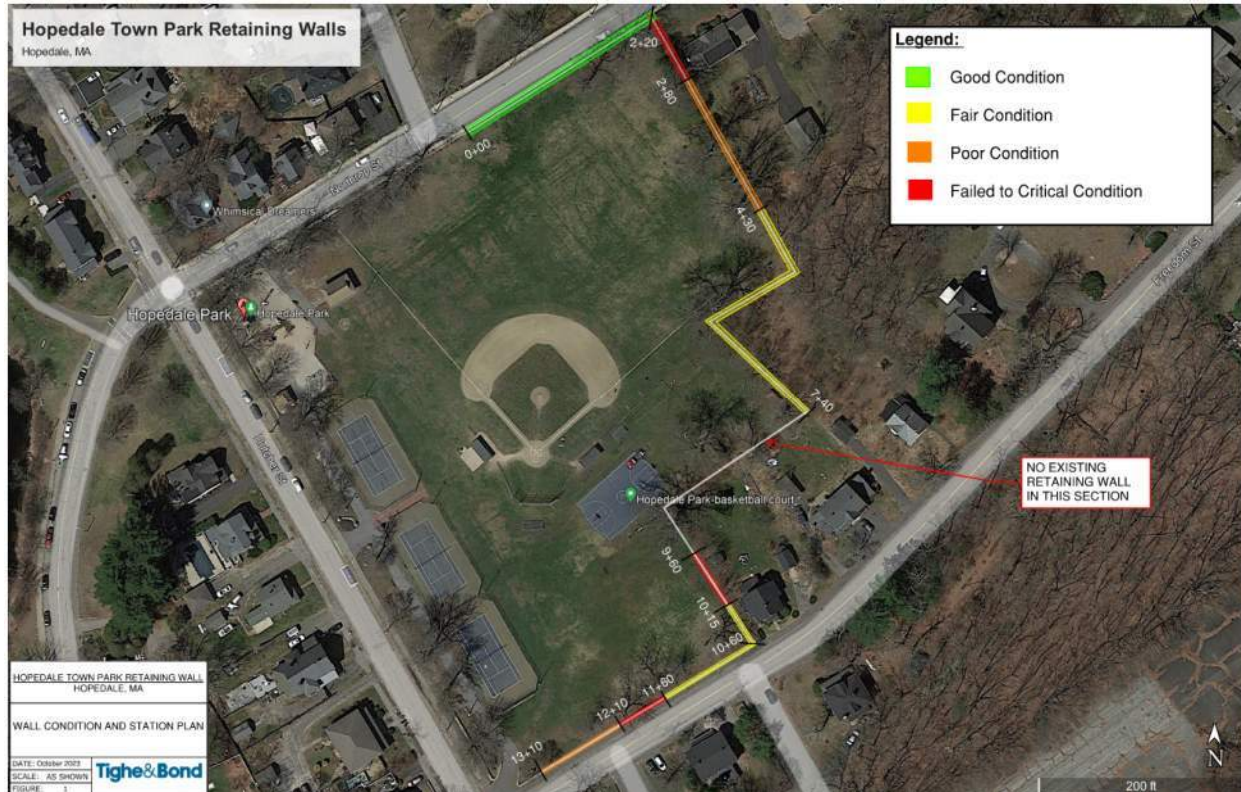
**Figure 2: Evaluation Stationing and Conditions**

Condition of the wall ranged from poor to critical/failed condition with multiple stones missing from the wall and severe outward leaning of the wall ( $\pm 12''$ ). See below for a list of deficiencies noted:

This section of wall was in critical/failed condition. Deficiencies noted include the following:

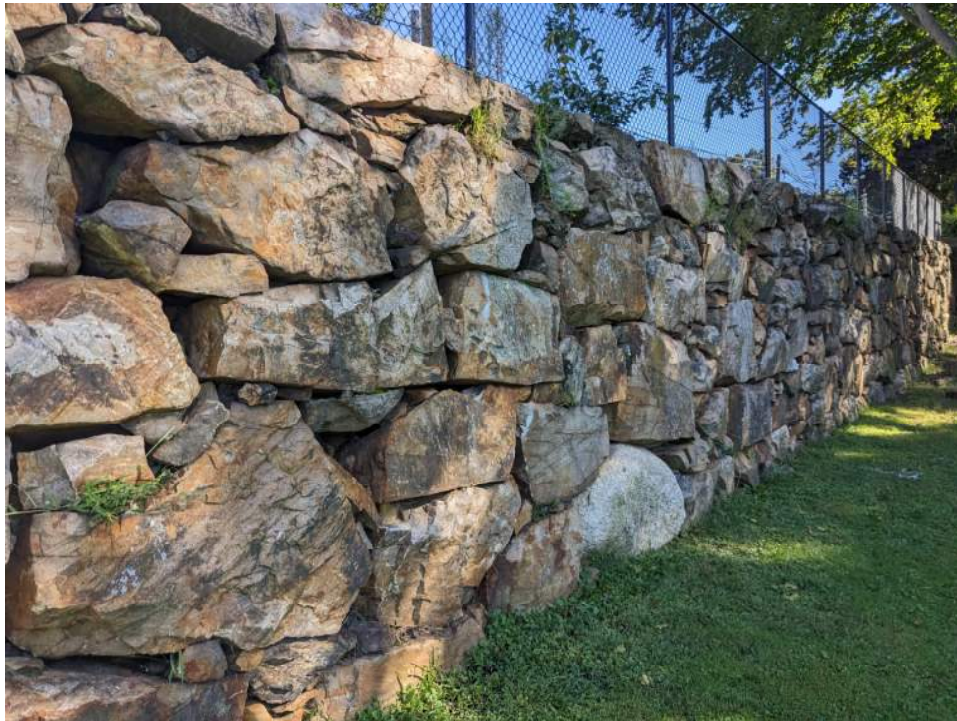
This wall section was in overall good condition. See below for a list of deficiencies noted:

*Photo 1: View of northwest wall adjacent to Northrop Street, facing north at sta. 1+30*

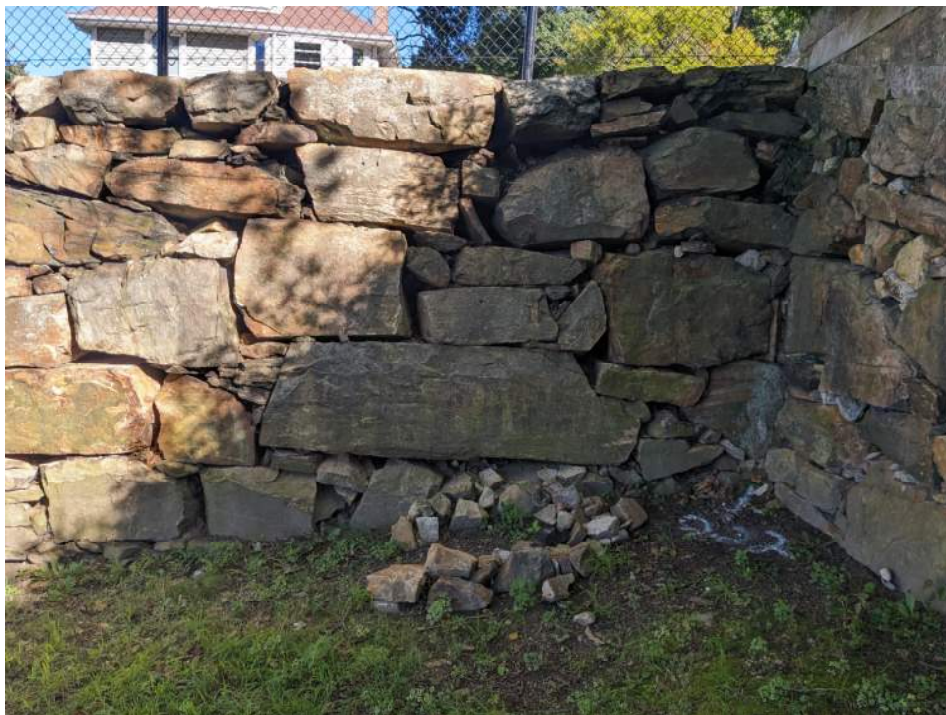
- STA 2+08 to STA 2+20 - Voids between stones up to 12-inches wide and 18-inches deep where chinking stones appeared to have fallen out over time (Photo No. 2).

*Photo 2: View of northwest wall adjacent to 25 Northrop Street, facing northwest at sta. 2+20*

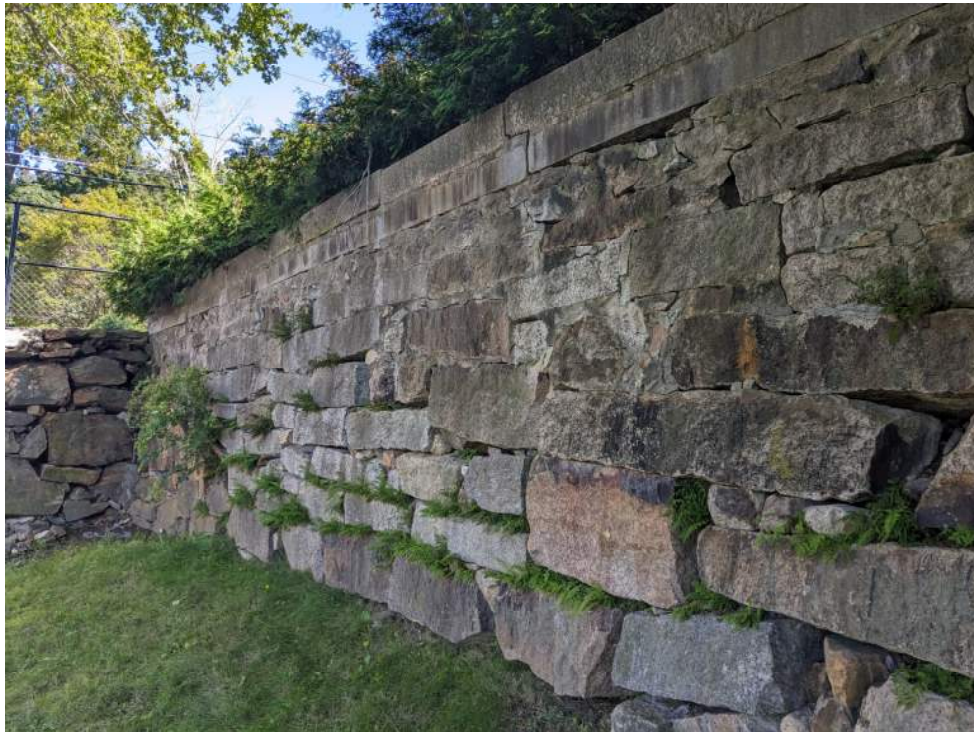
mortared stone followed by 2 additional rows of stone blocks connected with mortar to create the top of the wall (Photo No. 3).

*Photo 3: View of wall adjacent to 25 Northrop Street , facing north at sta. 2+40*

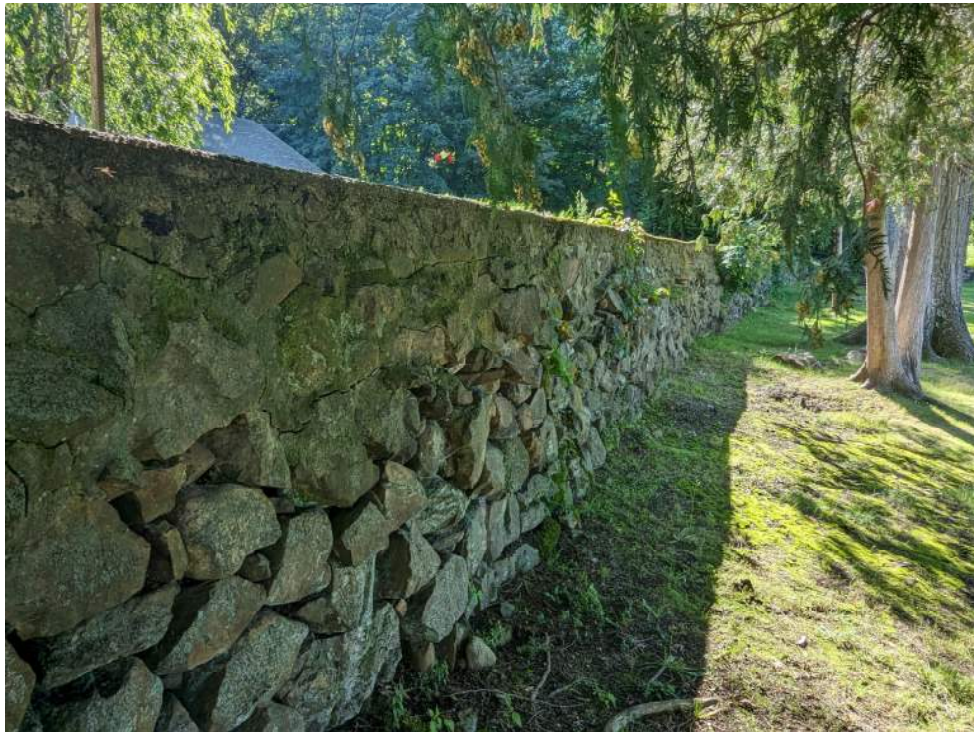
The wall in this section runs along the northern border of the park and abuts the properties at 25 Northrop Street and 44 Freedom Street. This wall section transitions from more uniform blocks at the northern end to boulders of various sizes and shapes, with the typical stone size ranging between 12 to 16-inches. The wall had a concrete leveling cap to provide a consistent top elevation (Photo No. 5). The wall height ranged from approximately 4 to 4.5-feet tall.

This section of wall was in poor condition. Deficiencies noted include the following:

*Photo 5: View of northeast wall with grouted stone cap, facing southeast at sta. 3+25*

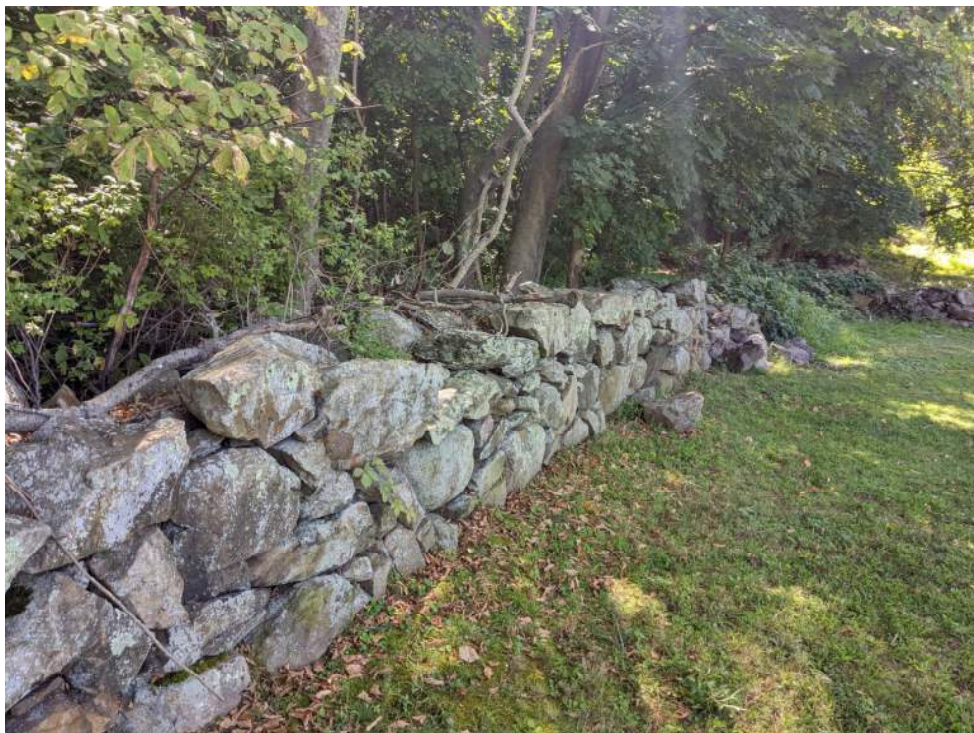
This wall section runs along the eastern border of the park and abuts the properties at 44, 50, and 54 Freedom Street. The wall ranges in height from 3 to 3.5 feet, and is freestanding, with no difference in grade on either side of the wall. The wall consists of dry stacked stones ranging in size from approximately 18 to 36-inches (Photo No. 8).

The wall was in poor condition. Deficiencies noted include the following:

*Photo 8: View of dry stacked stone wall, facing southeast at sta. 4+50.*

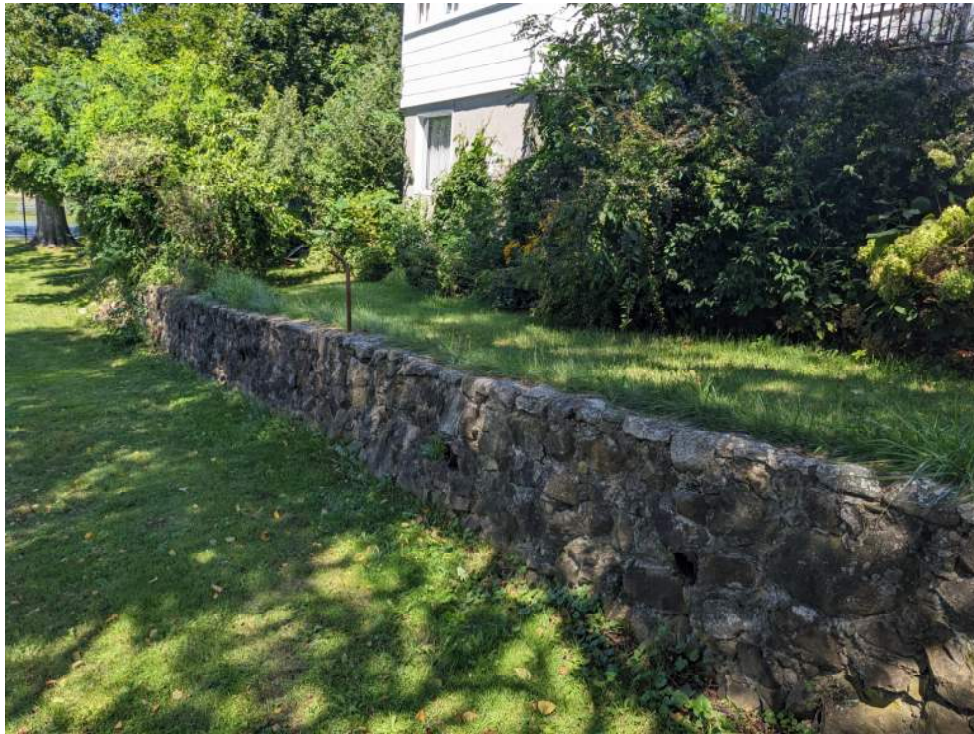
The wall was in fair condition with no significant instability. Deficiencies noted include the following:

- Entire Length - Minor cracking visible in the mortar between the wall stones.
- Entire Length - Minor vegetation growing within the wall cracking and/or overtop the wall.
- STA 10+17, 10+30, 10+46, & 10+52 - Weep drains filled with sediment and are no longer providing drainage from behind the wall.

*Photo 13: View of cobble wall adjacent to 62 Freedom Street, facing north at sta. 10+60*

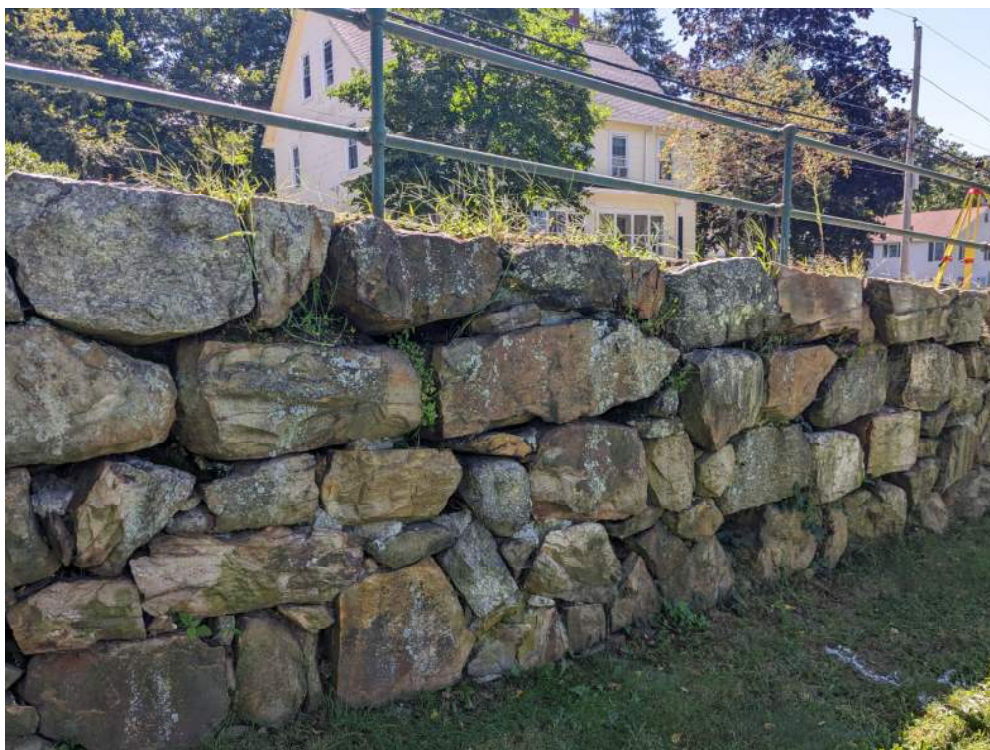
This wall section was in in fair condition with no significant instability. See below for a list of deficiencies noted:

*Photo 14: View of Freedom Street wall, facing south at sta. 11+00*

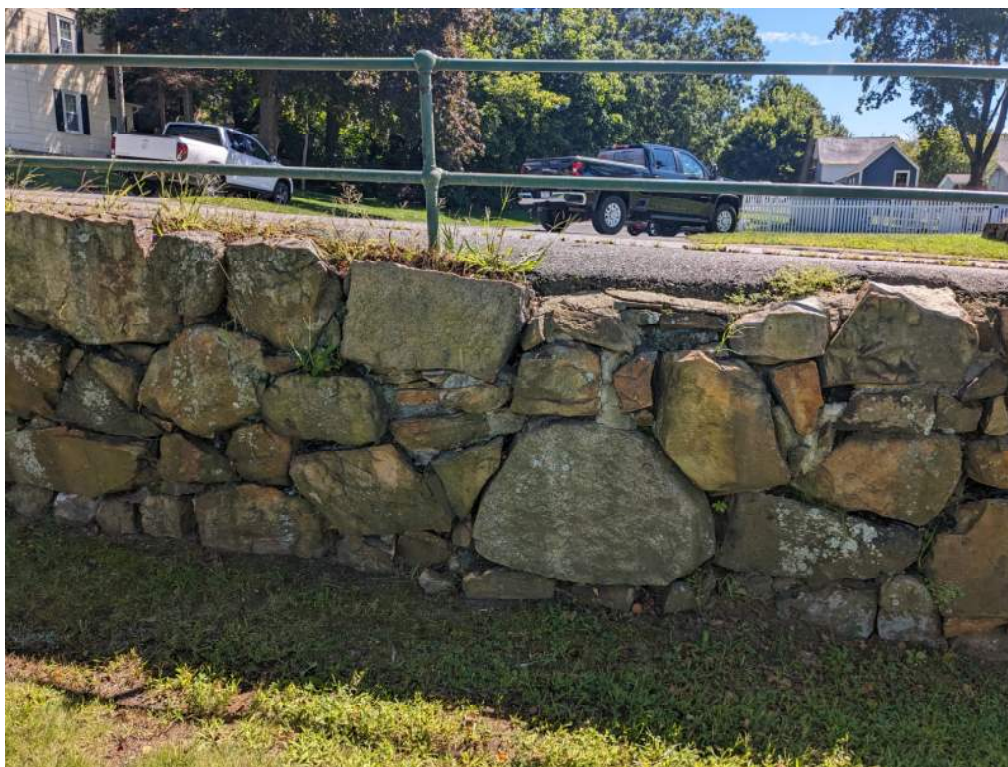
*Photo 18: View of Freedom Street wall, facing south at sta. 12+50*
